MANGGAR DAM RISK ASSESSMENT BASED ON THE ANDERSEN MODIFICATION METHOD

Yudha Pratama Narra Putra^{1*}, Ignatius Sriyana², Suprpto³

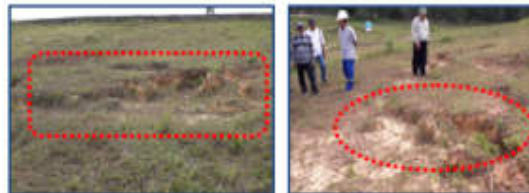
Figure 5 Downstream Slope Conditions of the Dam

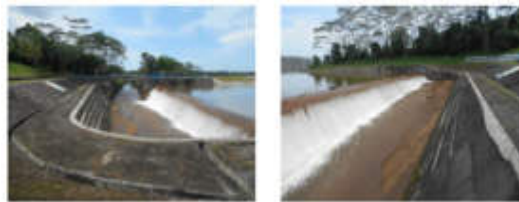
Figure 6 Dam Spillway Conditions

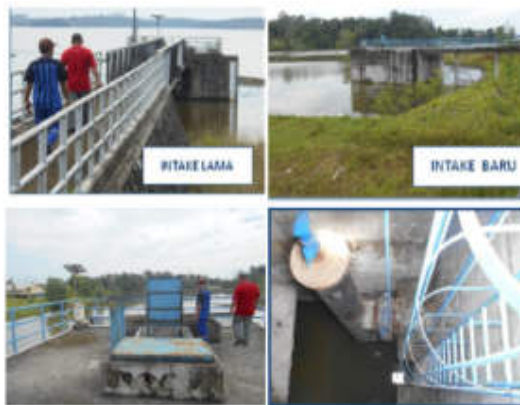
Figure 7 Dam Intake Conditions

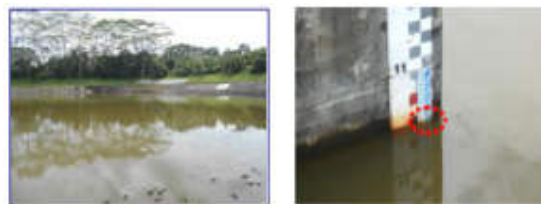
Figure 8 Water Conditions of Manggar Reservoir
