# Analysis of the Hatch Cover Maintenance System on the Mv. Ocean Perkasa to Support Smooth Loading and Unloading Processes

Hatch covers are vital components on the bulk carrier MV. Ocean Perkasa, functioning to maintain weathertightness to protect dry bulk cargo from damage. This study aims to determine the hatch cover maintenance system procedures and analyze their influence on the efficiency and smoothness of loading and discharging activities in port. The research method used is descriptive qualitative, with data collection techniques including direct observation, in-depth interviews with the Chief Officer, and documentation studies. The results of the study indicate that although maintenance followed the Planned Maintenance System (PMS), significant operational obstacles were still encountered. An incident involving a burst hydraulic jack pipe occurred on December 20, 2024, which caused a loading/discharging delay of 4–5 hours due to a failure in the hatch opening system. The primary causes were corrosion on the hydraulic connection pipes and dirty oil filter conditions, which triggered extreme pressure. The use of an Ultrasonic Tightness Tester proved to be more effective an

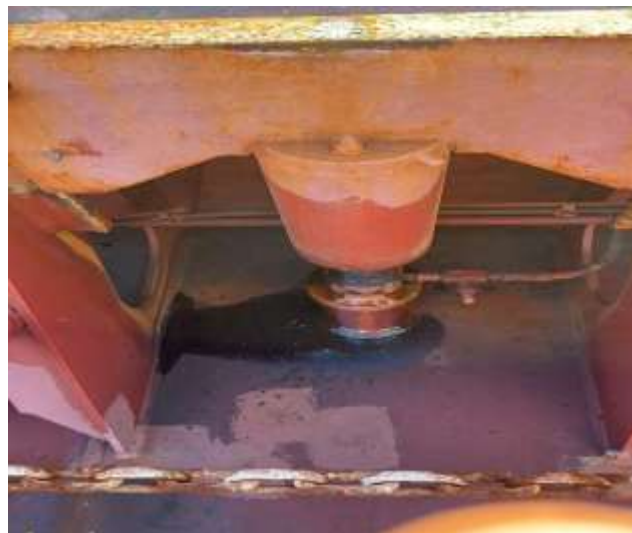
**Figure 3.** Hydraulic Hatch Cover  
Source: MV. Ocean Perkasa

Figure 3 shows the hydraulic drive unit, the main component of the Side-Rolling Hatch Cover system on the MV. Ocean Perkasa. Based on field observations, this system consists of several integrated components to support optimal hatch opening and closing. One of the main components is the Hydraulic Jack or Hydraulic Cylinder, which functions to lift the hatch panel before moving it horizontally using a rack and pinion drive system. This component plays a crucial role in ensuring stable and safe hatch movement.

Furthermore, there are Hydraulic Piping and Hoses, which serve as high-pressure fluid distribution lines from the main pump to each hydraulic cylinder on the ship's deck. This piping system serves as the primary connection in the distribution of hydraulic power, so it must always be ensured that the pipes are free from leaks and damage to ensure stable system pressure during operation. This system also utilizes Flexible Hoses, flexible rubber hose connections that allow for dynamic movement when the hatch panel is opened or closed. The presence of this flexible hose helps maintain the smooth operation of the hydraulic system while reducing the risk of damage due to continuous mechanical movements during ship loading and unloading activities.

Referring to the technical diagram in Figure 3, the removed pipe is a critical part of the hydraulic fluid distribution line that powers the Hydraulic Pot-Lift component. This component transmits pressure from the pump to the hydraulic cylinder to lift the hatch panel before it is moved horizontally via the rack and pinion drive system. Damage to the connection pipe, such as a leak or rupture, directly impacts the operational failure of the entire hatch system, as hydraulic pressure cannot be optimally distributed.

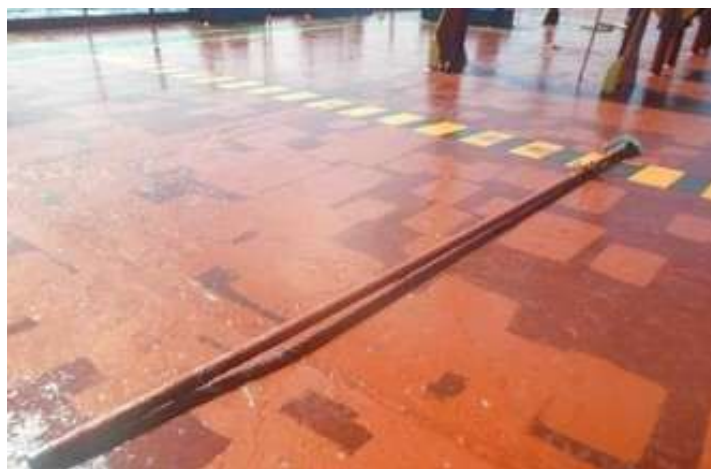
**Figure 5.** Removal of Hydraulic Connection Pipe  
Sumber : MV. Ocean Perkasa

During the operation of the hatch closing system on the MV Ocean Perkasa, one of the corrective maintenance actions carried out was the removal and replacement of the hydraulic connection pipe due to damage to the number 2 hatch drive system. The documentation in Figure 3 shows the hydraulic connection pipe removed from the hydraulic jack and placed on the ship's deck. Visual inspection revealed the pipe to be quite long, as it serves to reach a pressure point in the hydraulic pot-lift system. The pipe was removed after indications of a leak and a drastic drop in hydraulic pressure were detected, disrupting the hatch opening and closing process and hampering loading and unloading activities.

Based on an interview with the Chief Officer, the pipe removal was part of the inspection procedure following the damage. The initial step involved isolating the system by shutting off the hydraulic pump pressure to prevent an oil spray when the pipe was removed. The crew then dismantled the pipe connections at key points on the ship's deck in accordance with established technical procedures. After the removal and repairs were completed, the ship underwent a thorough inspection of the hold system to ensure there were no further impacts or other damage resulting from the hydraulic system disruption.

Based on a case study of a ruptured hydraulic connection pipe in hold number 2, the repair process was carried out under high time pressure because the damage immediately hampered loading and unloading processes. The ship's crew had to work in a coordinated manner under extreme weather conditions on deck to quickly replace the damaged pipe so the system could resume normal operation. The main technical challenge in the repair process was ensuring the precision installation of the steel pipe fittings. A small error, such as a tilted connection, could cause hydraulic fluid pressures reaching hundreds of bars, damaging the seal and triggering a re-leak. This situation demonstrates that the success of corrective actions is highly dependent on the hands-on technical skills of the crew, as well as the technical supervision and coordination of the Bosun.

After corrective actions are completed, the Chief Officer is required to conduct a Root Cause Analysis to determine the root cause of the damage. In the case of the hydraulic pipe rupture, the investigation revealed that the damage was not only caused by the age of the pipe but also by a surge in back pressure that could not be properly filtered due to a dirty filter. The results of this analysis will serve as evaluation material for ship management to tighten the implementation of preventive maintenance on the hydraulic system so that similar incidents do not recur in the future.

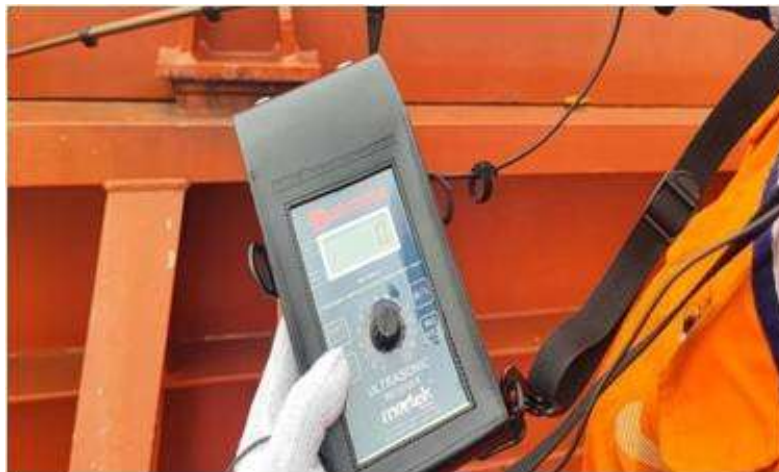
**Figure 6.** Inspection using an Ultrasonic Tightness Tester  
Source: MV. Ocean Perkasa

Pressure and leak testing of the hatch cover system on the MV. Ocean Perkasa is carried out through a hydraulic system inspection and hatch tightness testing. Hydraulic pressure checks are performed through a hydraulic control unit that monitors the working pressure in the Hydraulic Pot-Lift components and hydraulic cylinders. This system allows the ship's crew to directly monitor the operating pressure. A drastic drop in pressure indicates a leak or damage to the hydraulic connection pipes, requiring further inspection of the fluid distribution system.

In addition to the hydraulic pressure check, a watertightness test (leak test) is also performed to ensure there are no gaps or leaks in the hatch seals. This test uses an Ultrasonic Tightness Tester, which works by detecting ultrasonic signals passing through gaps in the rubber gasket. This tool allows for more precise hatch tightness measurements, allowing for early detection of potential leaks before they cause damage to the cargo or disrupt ship operations.

One key application of this predictive strategy is the use of an Ultrasonic Tightness Tester as a tool to mitigate the risk of cargo damage. The use of this technology represents a significant advancement in hatch

cover maintenance management, as it complies with IMO Circular MSC/Circ.1061, which recognizes ultrasonic testing as a valid method for verifying weathertightness. In practice, the use of this tool eliminates the need for hose tests, which require large amounts of water and risk wetting drainage ditches when the hold is loaded. Using this tool, the Chief Officer can more accurately predict the wear level of the rubber gasket based on the detected decibel value. If the indicator shows a high value, the crew can immediately plan gasket replacement before seawater leakage occurs and damages moisture-sensitive cargo.

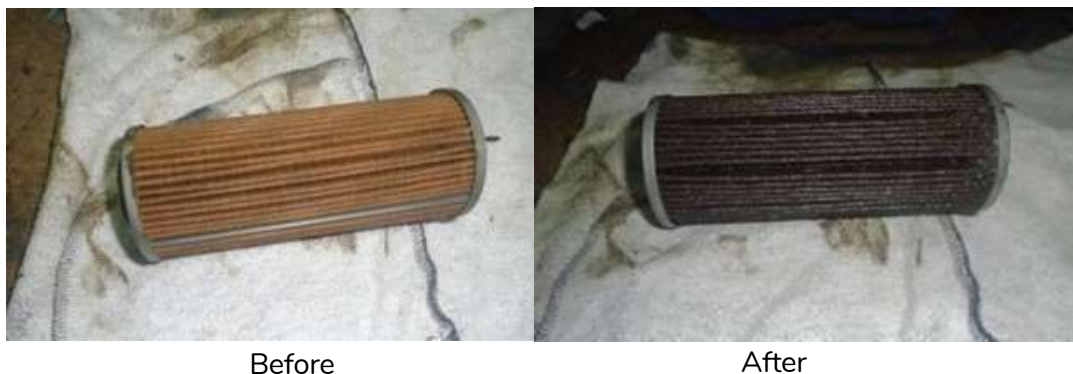
**Figure 7.** Hydraulic Oil Filter  
Source: MV. Ocean Perkasa

Hydraulic Oil Filter Maintenance Figure 5 shows the condition of the Hydraulic Oil Filter, removed for inspection and eventual replacement. This filter functions to filter contaminants and microparticles from the hydraulic oil that drives the Hydraulic Pot-Lift. A clean hydraulic system ensures smooth movement of the hatch panel on the rails. A clogged filter can overload the pump, potentially causing extreme pressure in the connecting pipes. Therefore, regular filter replacement is part of preventative maintenance to prevent sudden hydraulic system failure..

From a financial and technical risk management perspective, preventive maintenance of hydraulic oil filters plays a crucial role in preventing chain failures in hydraulic systems. Clogged filters can cause cavitation in hydraulic pumps, triggering oil temperature increases and overpressure. On the MV Ocean Perkasa, the crew's discipline in regularly changing filters is considered to reduce the risk of major damage, which can

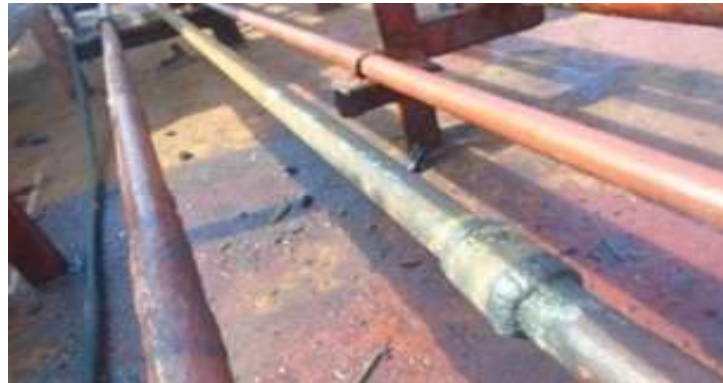
**Figure 8.** Reinstallation of Hydraulic Pipes

After removing and repairing the hydraulic system, the next crucial step was reinstalling the hydraulic piping components to restore the hatch cover's operational function. The repaired hydraulic piping was reinstalled on the ship's deck. This process involved reconnecting the steel piping connecting the pump unit to the Hydraulic Pot-Lift component. The crew ensured that each fitting was securely locked to prevent recurrence of fluid pressure leaks that could disable the hatch mechanism. Along with the piping installation, a new or cleaned Hydraulic Oil Filter was also installed. This ensured that the hydraulic fluid circulation remained clean from contaminating particles that could damage the pipe walls or clog the side-rolling cover control valves. Once all piping was reconnected, the system was reactivated to perform a hatch opening and closing function test. Based on interviews, a thorough inspection of each related system was conducted post-repair to ensure there were no cascading effects from previous damage. As a final step to validate the success of the repair, the crew used an Ultrasonic Tightness Tester. This inspection ensures that the hatch is not only mechanically movable but has also achieved optimal weathertightness, indicated by a zero or safe indication on the device's digital display.
